BEFORE THE IDAHO PUBLIC UTILITIES COMMISSION

IN THE MATTER OF DIAMOND BAR)	
ESTATES WATER COMPANY'S)	CASE NO. DIA-W-15-01
APPLICATION FOR AUTHORITY TO)	
INCREASE ITS RATES AND CHARGES FOR)	COMMENTS OF THE
WATER SERVICE IN THE STATE OF IDAHO.)	COMMISSION STAFF
)

On August 27, 2015 AEI Engineering, Inc. made its initial site visit for the purpose of providing condition assessment and evaluation of the well house's electrical system serving the well pump. The scope of this evaluation included analysis of the utility service, surge protection devices, grounding system and pump motors.

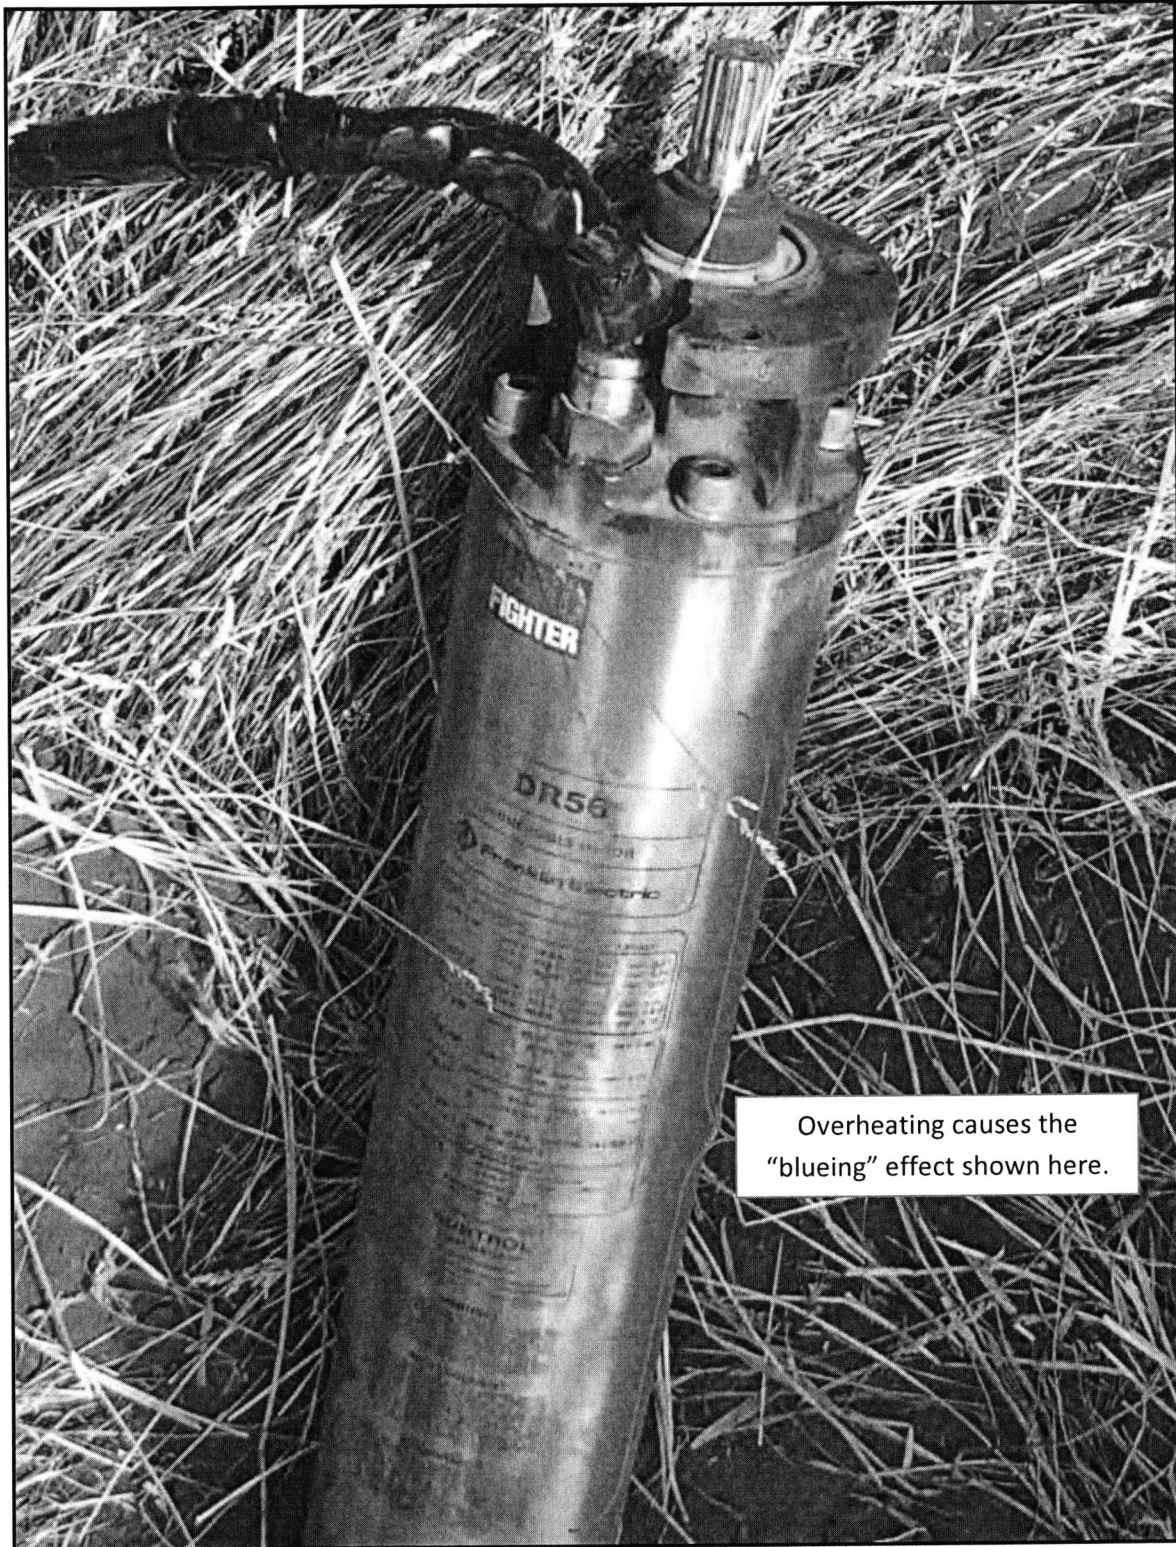
Figure 1: Failed 6" well pump motor

On September 1, 2015 AEI observed the existing 6" pump motor being removed from service and exchanged with a new 8" 60 HP pump. After being removed, AEI observed the existing pump motor to have "blueing"; evidence of overheating. See appendix A. This is the fourth time the motor has been replaced since November 2012.

1. Replace all end connectors on grounding system. Due to the sites history of lightning strikes, replacing all of the end connections of the grounding conductors will give the electrical system a more solid grounding system. This will provide increased protection from lightning and faults in the system.
2. Install a new SPD to protect the service entrance of the system in addition to the existing monitoring and protection equipment currently in use. At a minimum, provide the following SPD:

- a. Service entrance protection (Square D, HWA-80KA).
3. Provide a larger 112.5 KVA, 480V/277, Wye connected service transformer. Preferably, a pad mount type located next to the building.
4. If the service is not upgraded, replace the existing service fused disconnect.
5. Replace the FVNR across-the-line starter serving the well pump with a solid state soft starter.
 - a. The soft starter will not only be less stressful on the electrical system (reduced inrush current) and pump motor but will also provide a higher level of protection to the motor while running.
